Sacramento's Crocker Art Museum Expansion Required Delicate Measures

California Construction

October 07, 2010

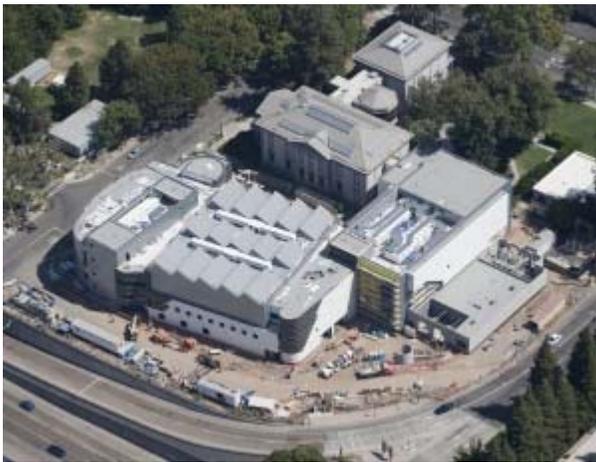
With the opening of the \$80-million, 125,000-sq-ft expansion of the historic 1872 Crocker Art Museum in Sacramento, it will not be the first time that contractors see the building in all its three-dimensional glory.
