WRAPSHIELD® RS RAIN SCREEN

STUCCO

Restoration

Luxury Residence Suffers Extensive Moisture Damage

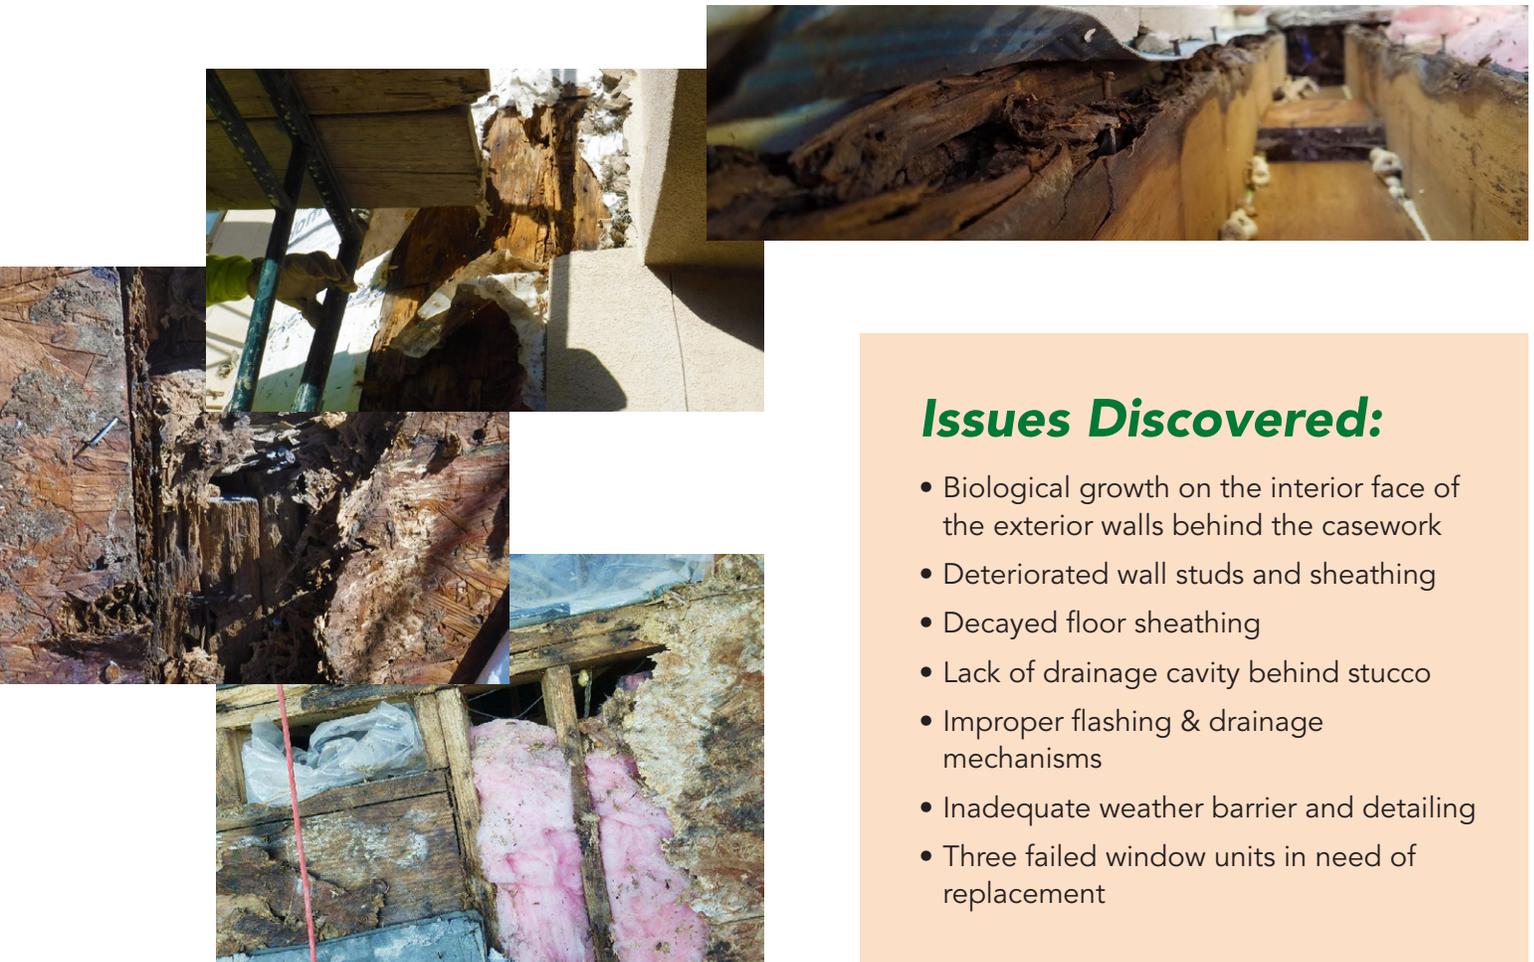
During water mitigation from the sprinkler line rupture, the contractor opened up the interior side of some exterior walls and discovered extensive moisture damage that was not caused by the ruptured sprinkler line.

- Biological growth on the interior face of the exterior walls behind the casework
- Deteriorated wall studs and sheathing
- Decayed floor sheathing
- Lack of drainage cavity behind stucco
- Improper flashing & drainage mechanisms
- Inadequate weather barrier and detailing
- Three failed window units in need of replacement

Pie Consulting & Engineering was retained on the project to provide an assessment of the as-built conditions/damages, act as the designer-of-record for a full exterior re-cladding, as well as to provide quality assurance and testing services during the work. Throughout the design and remediation, Pie worked closely with VaproShield's Technical Team to create a rainscreen system that would provide a long-term performance solution for the client.

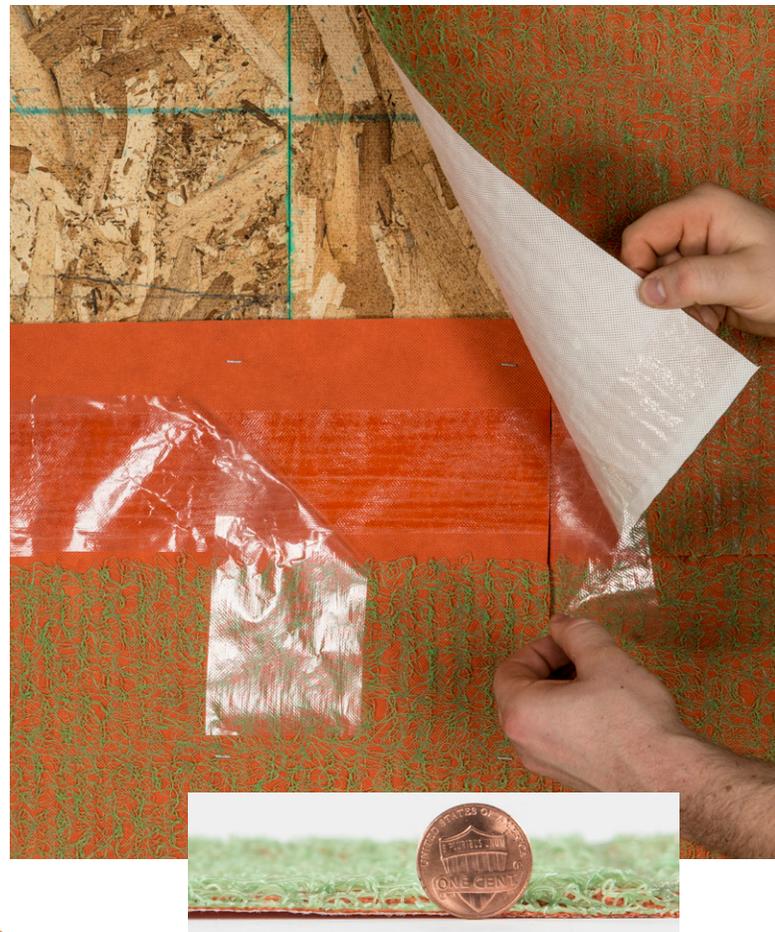
One Step
WRB
Rain Screen

Designed with factory installed drainage matrix

- Mechanically attached water resistive (WRB), vapor permeable air barrier (AB)
- Built-in 3mm rain screen drainage matrix creates unimpeded drainage plane behind stucco
- Factory-installed horizontal tape easily creates shingle effect overlaps
- Fully tested rough opening flashing accessories eliminates purchase of additional tapes/sealants

WrapShield RS Rain Screen 3mm was selected as the material of choice, due to its built-in 3mm rainscreen drainage matrix and integrated tape at the horizontal seams. The material properties offered an unimpeded vertical drainage plane behind the stucco, as well as higher drying capacity.

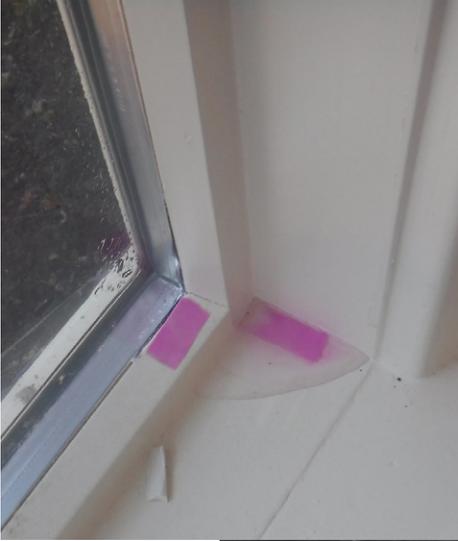
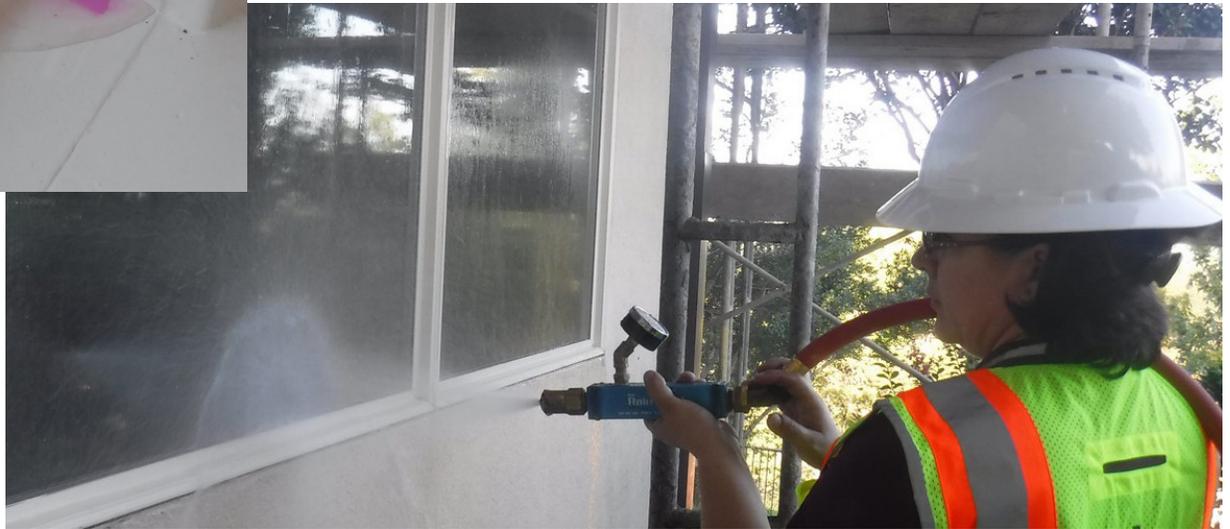
The home's windows were suspected to be a contributing factor for additional moisture damage, so the consultant performed window spray tests to confirm the leak sources. Three window units were identified as leaking and were removed and replaced.

Using the Two-Part Simplified flashing system from VaproShield, the window penetrations were expertly installed to ensure long term moisture resistance.

- 1 VaproFlashing SA Self-Adhered
- 2 VaproLiqui-Flash
